2014 Soil Survey of Palmer Lake Field Geological Engineering Report

March 12th, 2014

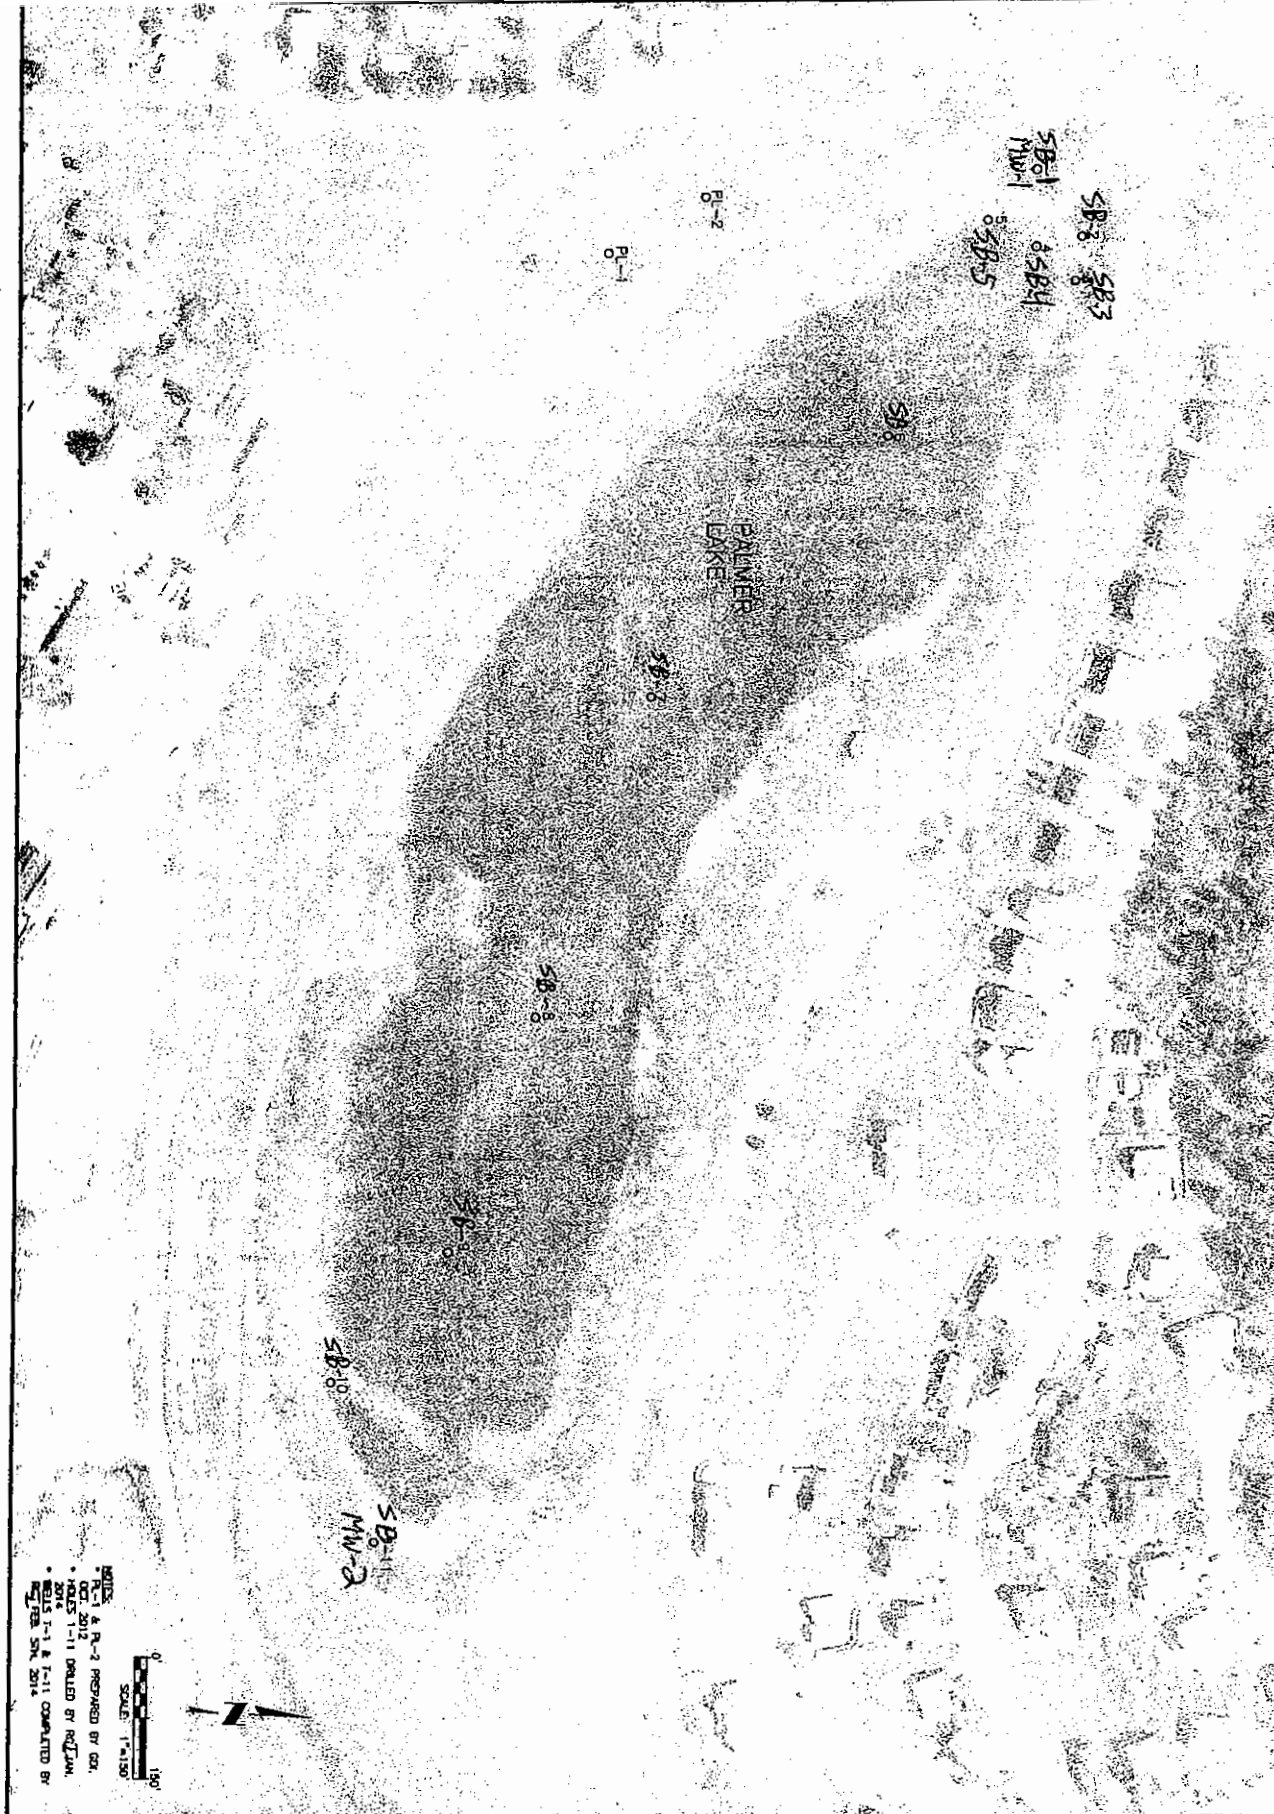
NOTES:
 1. SB-1 & SB-2 PREPARED BY GRI,
 OCT. 2012
 2. SB-3 THROUGH SB-10
 & MW-1 THROUGH MW-3
 PREPARED BY GRI,
 FEB. 2014

Through field examination similar distinct layers were noticed in most of the boring locations indicating a common stratigraphy across the entire lake bed. It also seems reasonable to believe that the sidewalls had some amount of overburden based on walking upslope around the lake perimeter. When the bank locations reached approximately the same elevation height as the lake bed borings, the layers of analyzed soil seemed fairly consistent with the same soil stratigraphy noticed in the lake bed itself. This will have to be confirmed or denied with soil and groundwater modeling. These initial results should be verified by analyzing the collected data and plotting the soil types at the differing elevations. JDS-Hydro Consultants (JDS) was on site and collected GPS data that could be used in conjunction here. An inclusive figure showing all of the collected locations is also attached within this report.

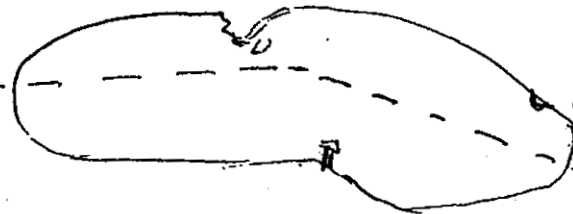
Location Map:

Boring / Well Number: SB-1 / MW-1	Project: Awake Palmer Lake
Date: January 27, 2014	Project Number:
Drilled By: Resource Geoscience	Logged By: Patrick Duby
Drilling Method: Direct Push	Sampling Method: 5' plastic liners
Casing Type: PVC	Diameter: 1" Length: 10' Hole Diameter: >1" Depth to Water:
Screen Type: PVC slotted	Diameter: 1" Length: 10' Boring Depth: 20' Depth Completed: 20'

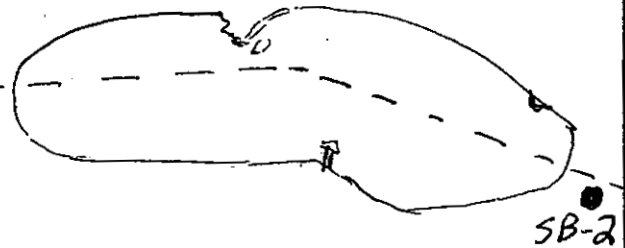
Location Map:

Boring / Well Number: **SB-2** Project: **Awake Palmer Lake**

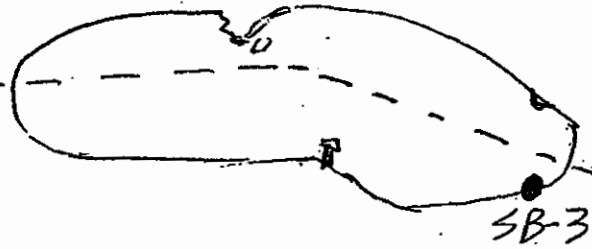
Location Map:

Boring / Well Number: **SB-3** Project: **Awake Palmer Lake**
 Date: **January 27, 2014** Project Number:
 Drilled By: **Resource Geoscience** Logged By: **Patrick Duby**
 Drilling Method: **Direct Push** Sampling Method: **5' plastic liners**

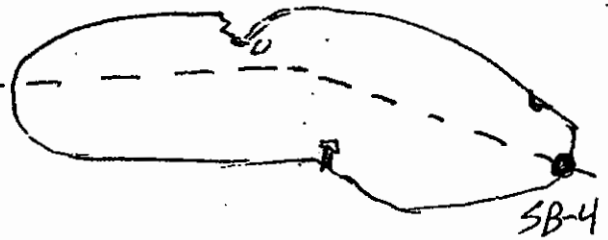
Location Map:

Boring / Well Number: **SB-4** Project: **Awake Palmer Lake**
 Date: **January 27, 2014** Project Number:
 Drilled By: **Resource Geoscience** Logged By: **Patrick Duby**
 Drilling Method: **Direct Push** Sampling Method: **5' plastic liners**

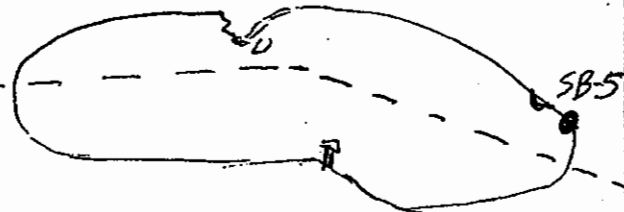
Location Map:

Boring / Well Number: SB-5 Project: Awake Palmer Lake
 Date: January 27, 2014 Project Number:
 Drilled By: Resource Geoscience Logged By: Patrick Duby
 Drilling Method: Direct Push Sampling Method: 5' plastic liners

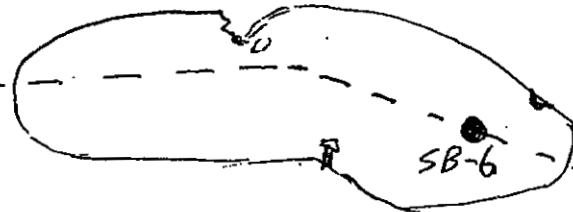
Location Map:

Boring / Well Number: **SB-6** Project: **Awake Palmer Lake**

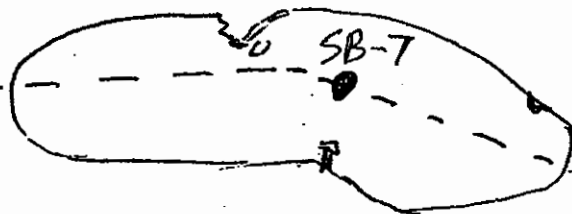
Location Map:

Boring / Well Number: **SB-7** Project: **Awake Palmer Lake**
 Date: **January 27, 2014** Project Number:
 Drilled By: **Resource Geoscience** Logged By: **Patrick Duby**
 Drilling Method: **Direct Push** Sampling Method: **5' plastic liners**

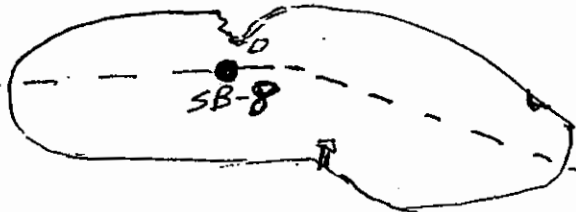
Location Map:

Boring / Well Number: SB-8	Project: Awake Palmer Lake
Date: January 27, 2014	Project Number:
Drilled By: Resource Geoscience	Logged By: Patrick Duby
Drilling Method: Direct Push	Sampling Method: 5' plastic liners

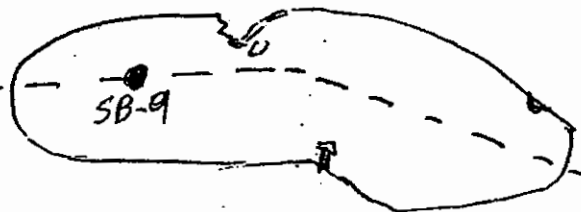
Location Map:

Boring / Well Number: **SB-9** Project: **Awake Palmer Lake**
 Date: **January 27, 2014** Project Number:
 Drilled By: **Resource Geoscience** Logged By: **Patrick Dwy**
 Drilling Method: **Direct Push** Sampling Method: **5' plastic liners**

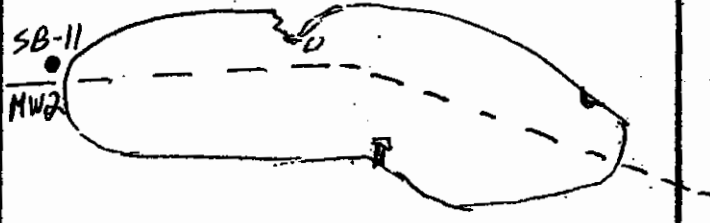
Boring / Well Number: SB-11 / MW-2	Project: Awake Palmer Lake		
Date: January 27, 2014	Project Number:		
Drilled By: Resource Geoscience	Logged By: Patrick Duby		
Drilling Method: Direct Push	Sampling Method: 5' plastic liners		
Casing Type: R/C	Diameter: 1" Length: 8' riser	Hole Diameter:	Depth to Water: 9' BGS
Screen Type: PVC slotted	Diameter: 1" Length: 5' screen	Boring Depth: 12.5'	Depth Completed:
